## INDIANA DEPARTMENT OF ENVIRONMENTAL MANAGEMENT

Re: **Inspection Summary/Violation Letter**  
Yard 520 Landfill  
Permit # 64-04/64-07  
Town of Pines, Porter County

# AGRICULTURAL AND SOLID WASTE COMPLIANCE

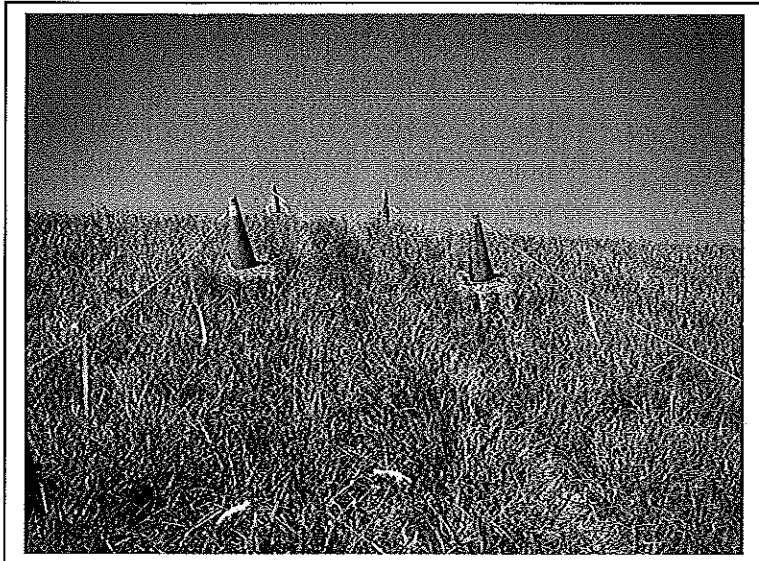
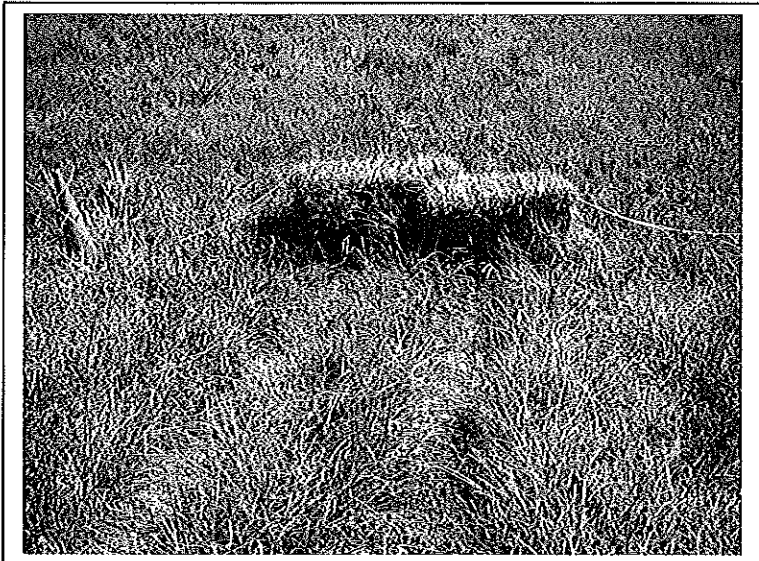
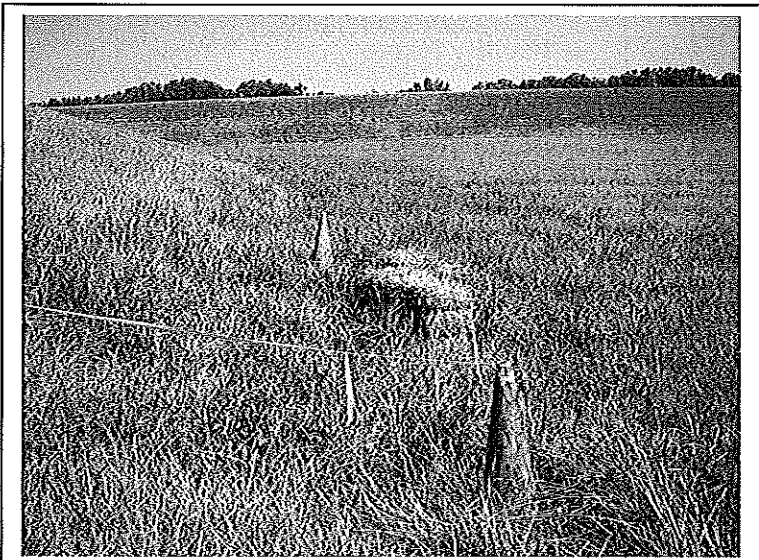
The areas of depression due to the ATV activity have been addressed by filling with topsoil and reseeding. The area on the East side of the South fill was observed to not be in compliance as the topsoil was observed to have been washed out and the vegetation did not sprout in this area. This area needs to be refilled with a more clayey soil in order for it to stabilize itself in place. It will also then need to be reseeded. The other tracks seen on the 12-10-2009 inspection are not noticeable now and vegetation has sprouted over the landfill without any other noticeable bare spots.

At this time the landfill is still in violation of 329 IAC 10-31-2(a) (4) Maintenance of the final contours of the facility in accordance with the applicable standards of 329 IAC 10-28 and 329 10-30 and at a minimum to provide that no ponding of water occurs on the

fill. This violation is still cited due to the two depressions on the East side of the South fill having the top soil wash out and no vegetation growing in this area. Ms. Blumenfeld stated that she would see about using clay instead of topsoil and then using a mesh blanket to hold seed in. This inspector indicated that that would be a good plan as the clay may stabilize itself in place better than the top soil. This repair needs to be made within 30 days of receipt of this notice and the work details need to be submitted to this inspector.

East slope of South fill where the repairs to the depressions made by ATV's had failed and the non-vegetated depressions remain. The area has been roped off using cones and straw bales.

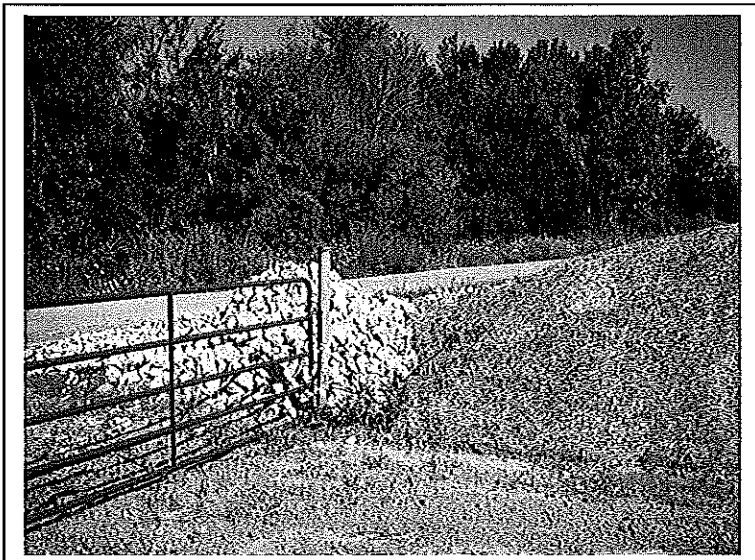
Access Control has been addressed by building a permanent berm along the North side of the Birch Street gate. A pile of riprap has also been placed cutting off this access point. "No Trespassing" signage has been reposted on this gate as well. The Brown Ditch is located to the South and East of the landfill keeping out trespassers. The ditch line was walked to ensure that there are not any access points and none were observed. No ATV tracks were observed on the landfill during today's inspection. The measures taken to control access appear to be sufficient at this time.

The Birch Street gate showing the newly constructed berm and rip rap pile to control access.

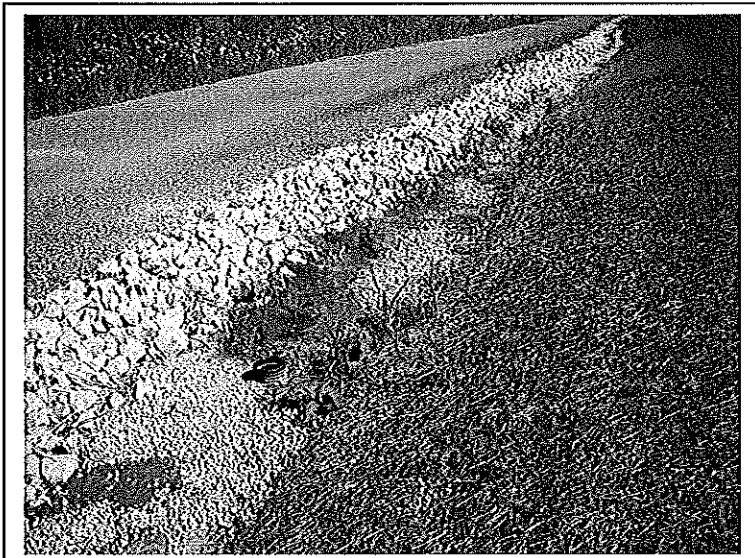
The stormwater ditch running parallel to Birch Street showing new gravel and a tile outlet.

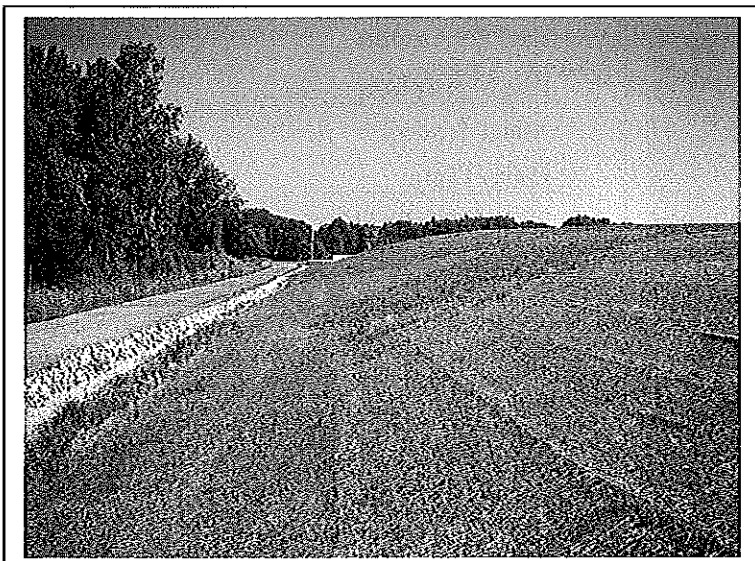
The seepage outbreak area on the West slope of the North fill was completely re-graded and the slope was re-contoured. The area was packed with clay and seeded. Per the completion repair report 730 cubic yards of clayey soil has been placed in this area. There is currently a mesh blanket over the seeded area as the vegetation has not completely sprouted yet. The storm water ditch line that runs parallel to Birch Street was also cleaned out and a new drainage tile was inserted to aid in moving storm water away from the landfill. This area looked to be in compliance and no leachate/ seepage was observed while on site today however in the last 48 hours the weather has been dry and warm.

The West slope of the North fill showing the areas that have been re-contoured and capped with clay. Vegetation is starting to sprout up here.
